HIGH WIRE ACT

When the lights went out at Kitimat, it was the cue for Rio Tinto Alcan to embark on one of its most complex engineering feats ever.

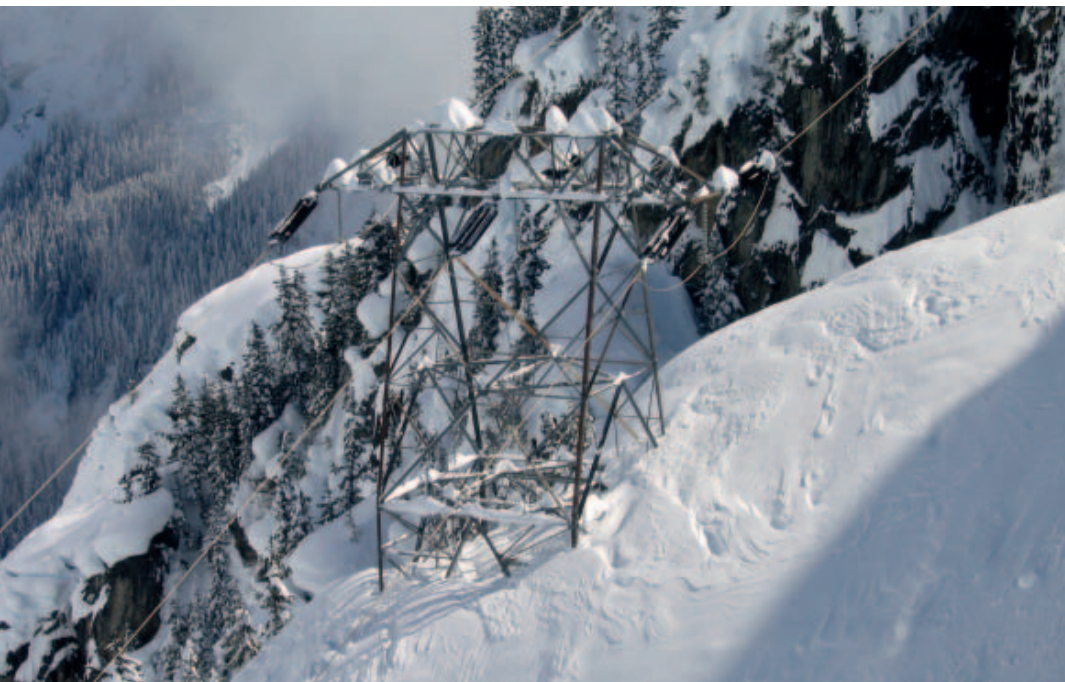
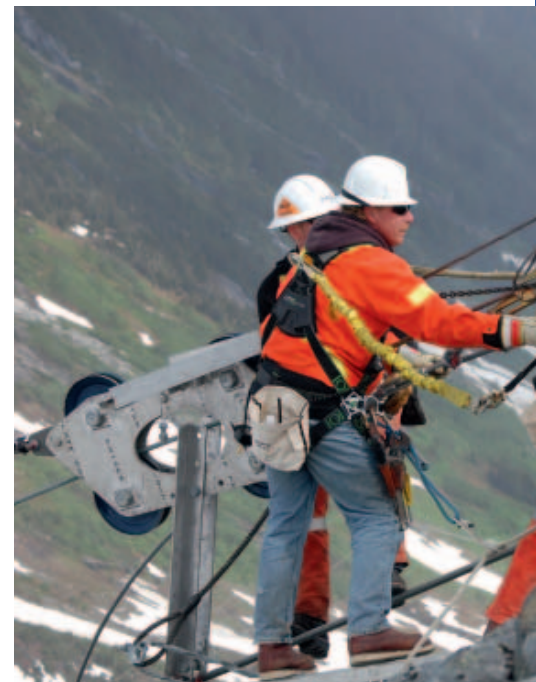
Below left, heavy winter snowfall, the norm in the rugged Kildala Pass. Below, crews installing one of the 28 individual cables that make up the catenary system. Right, in suspense – crews ready to connect the first conductor onto the new catenary. It took a complete day to raise and connect each conductor.

Work next began on pulling the 28 cables 1,000m across the valley. With the cables in place, workers then had to bind each of the seven sets of cables together to form two massive cables across the valley.

Raising the conductors from the ground required the use of a cable sling attached from a winch on a tractor over to a ground pulley, up to a pulley on the catenary and back down to the actual conductor. Once the cable was connected the winch was used to lift the conductor, weighing ten tonnes, up to the catenary itself – a process that took over an hour each time. During this lifting process the potential stress on the catenary itself was at its greatest: no one was allowed on the catenary until the conductor was lifted into mounting position with the insulators already attached below the catenary.

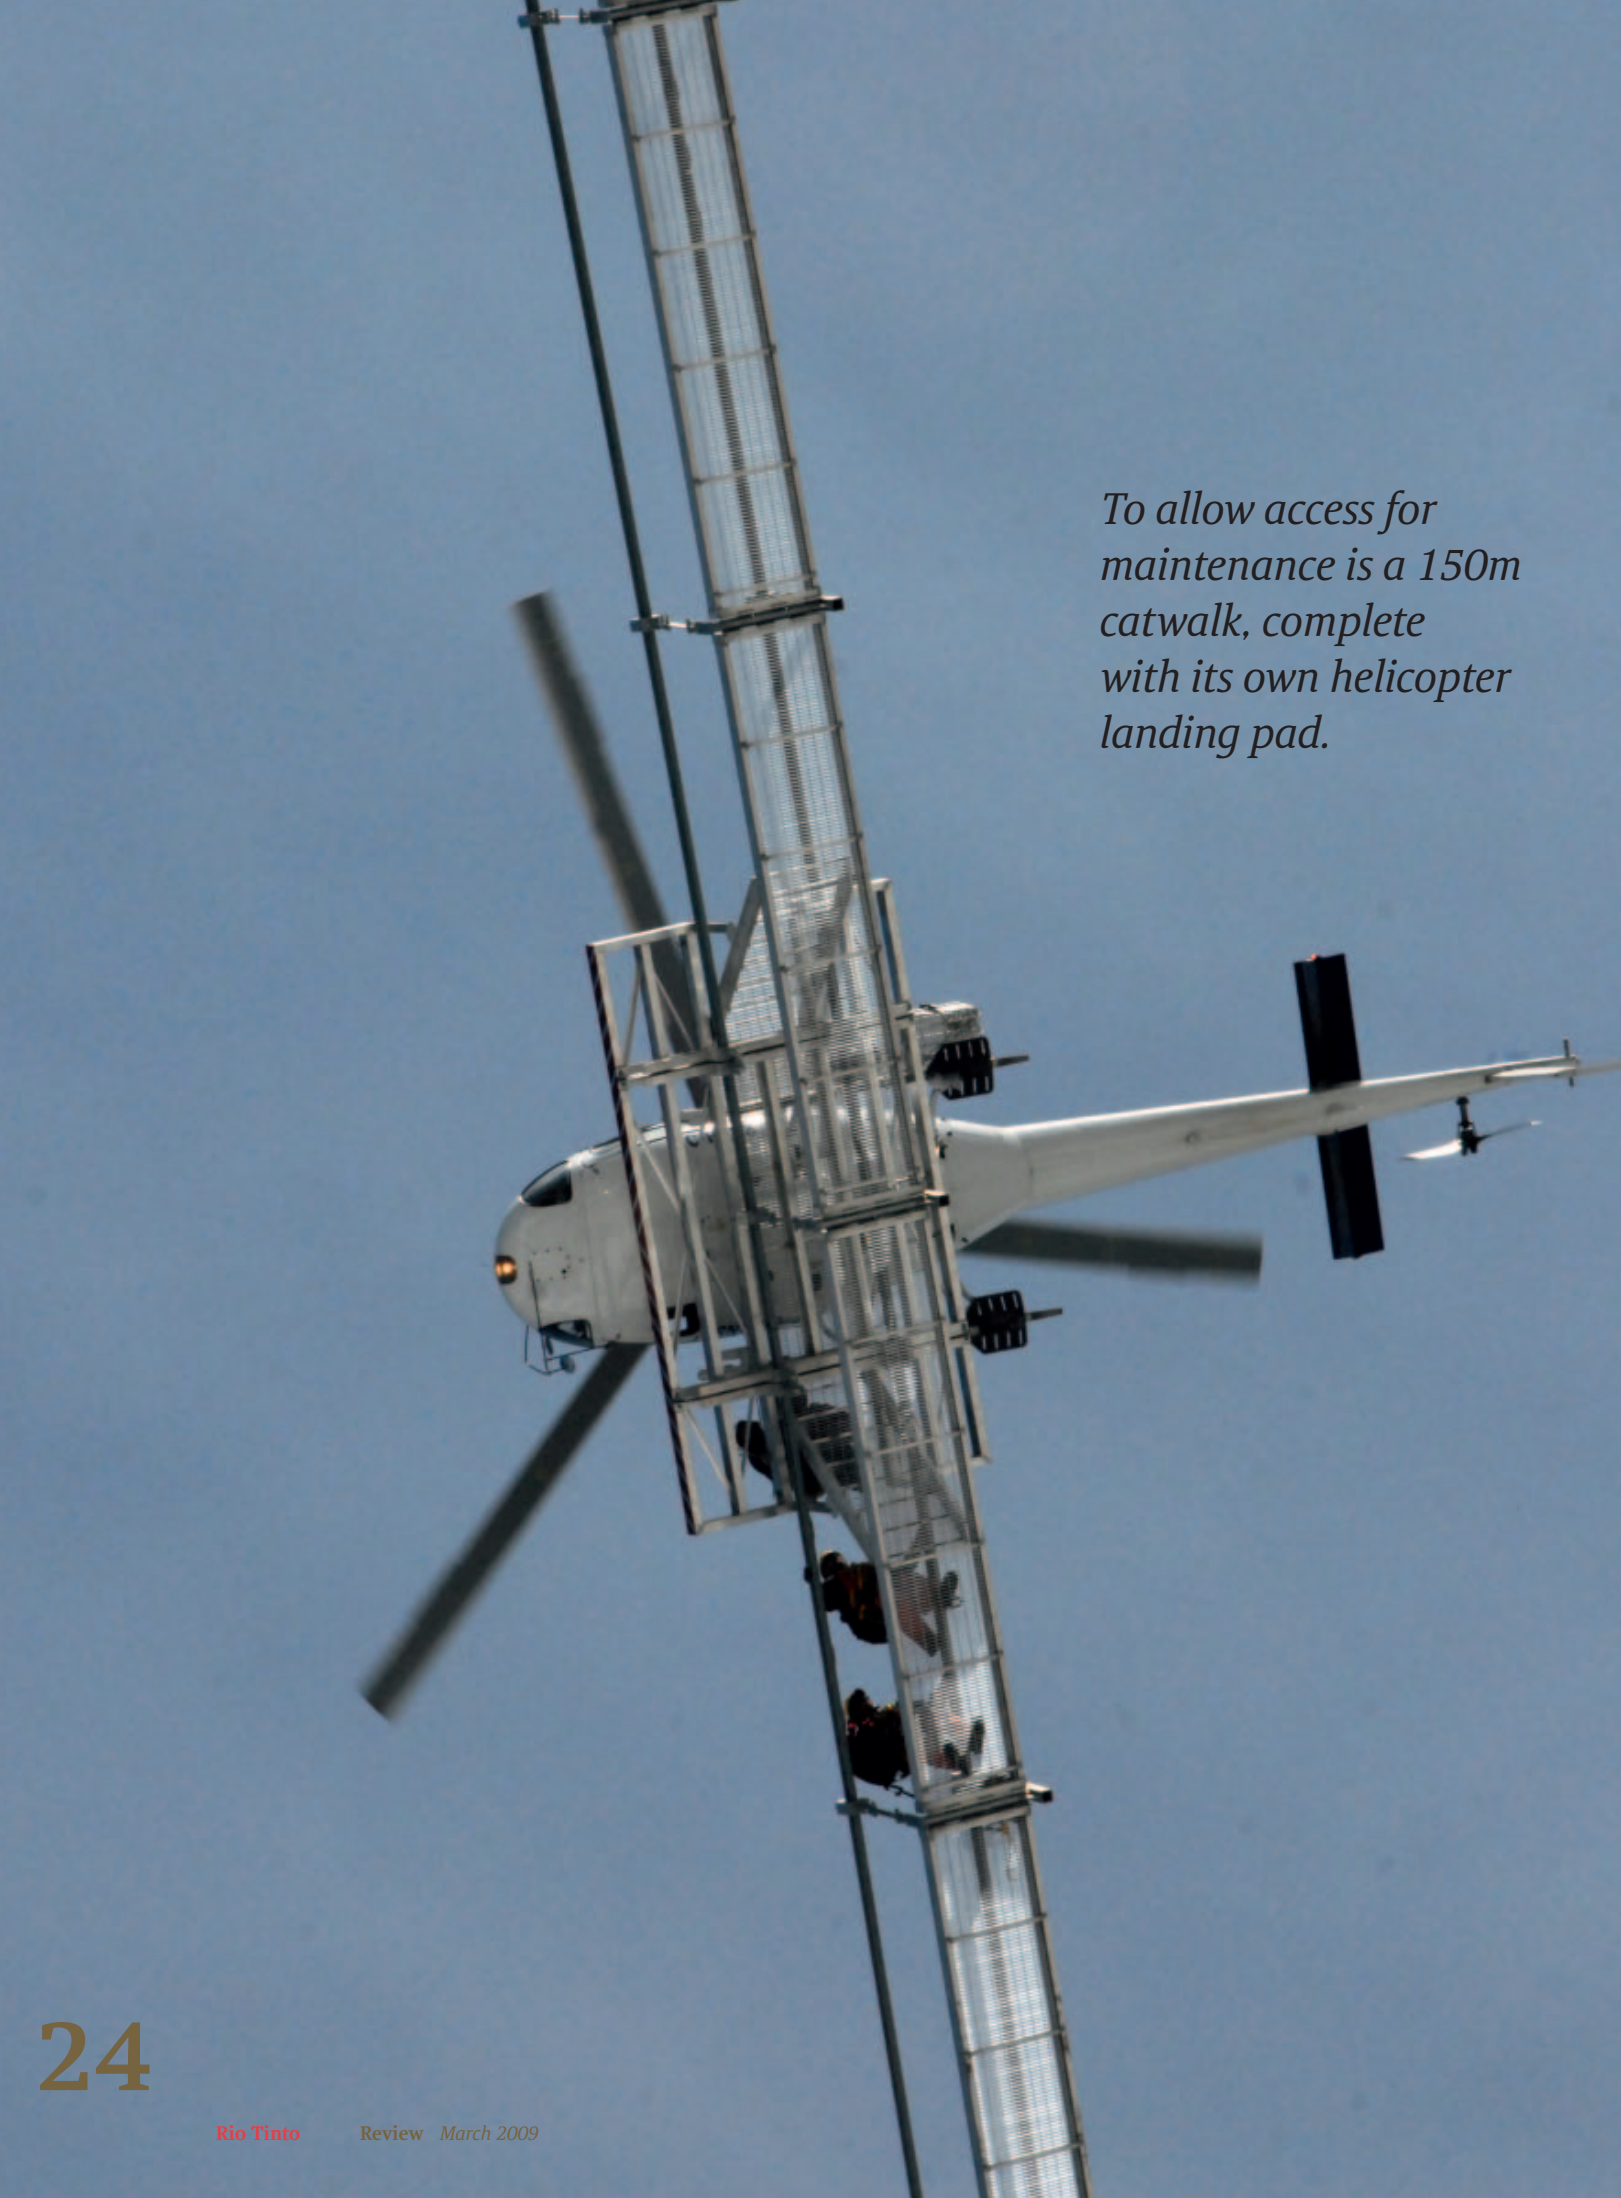
To allow access for maintenance is a 150m catwalk, complete with its own helicopter landing pad.

To accomplish this, linemen worked from carts that ran along the length of the cable. Helicopters were used to ferry the 26 catwalk panels into place while workers anchored them to the catwalk. Once the catwalk was put into place the final task was installing the new helicopter landing pad on top of the structure.

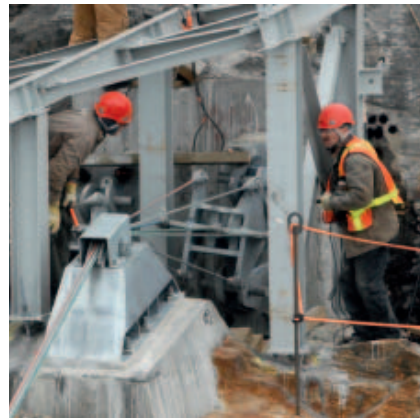
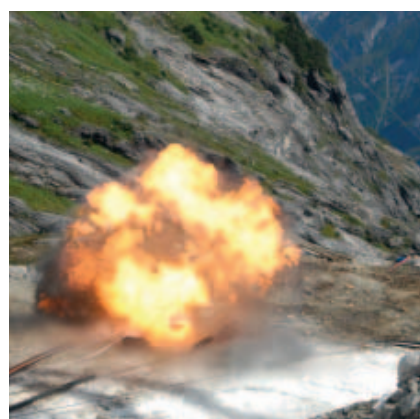
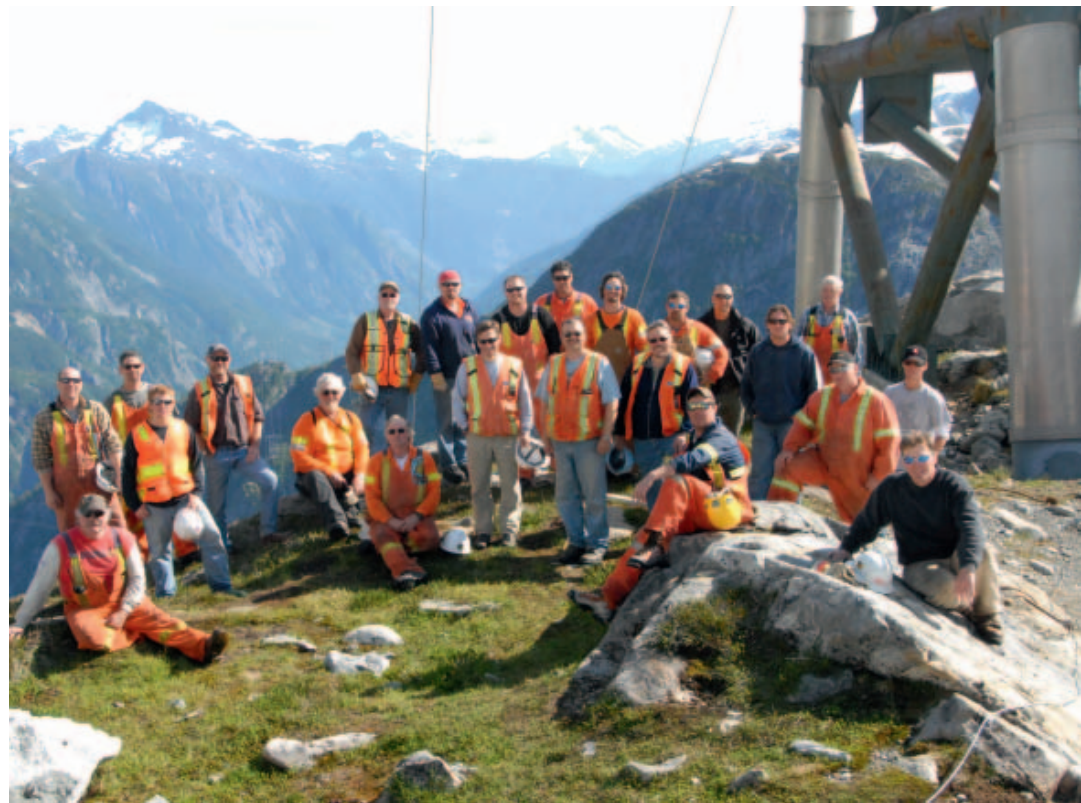
Left, at the centre of the catenary, above the maintenance catwalk, is a tiny helicopter pad providing access for men and materials. Below, top, a catenary anchor point on the side of the mountain. Each of the four anchor bases is protected within its own avalanche shed.

Centre: steady as she goes – all heavy equipment and materials had to be lifted in by helicopter.

Bottom: constructive blast. The easiest way to join power line conductors together is with the aid of explosives.

The location of this catenary required special engineering indeed. At the centre of the span, where the cables intersect with the transmission line, would be six insulators and each would weigh ten tonnes, excluding the actual cable it carried. Immediately above, to allow access for maintenance, would be a 150m catwalk, complete with – unbelievably – its own helicopter landing pad.

The first phase of the project consisted of building the four cable anchor points to the side of the mountain. Rock blasting crews and equipment arrived at their work locations daily by helicopter. The anchor area had to be cleared and six holes bored 6m deep into the side of the mountain for each of the four anchor bolts. Wet concrete was flown in continuously from Kitimat to build the actual cement anchors into the side of the mountain. When the bases were completed anchor plates and runners were installed onto each of the four bases.
